CASE STUDY

Boston College addresses corroding air handling units with AQUIS

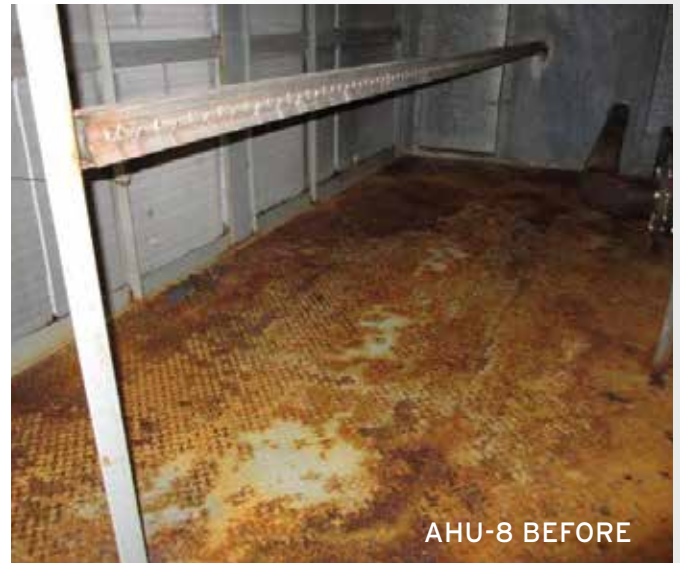
Higgins Hall is a science and research building on the main campus at Boston College, home to over 20,000 students in Chestnut Hill, Massachusetts. Their built-up air handling units, manufactured by Haakon Industries, had significant corrosion on the chamber floors and walls, resulting in holes that could potentially cause damaging water leaks in the building. Boston College selected AQUIS to refurbish the interior of six large units because they wanted to extend the life of the air handlers with a fully compliant and cost effective system.

AHU-8 BEFORE

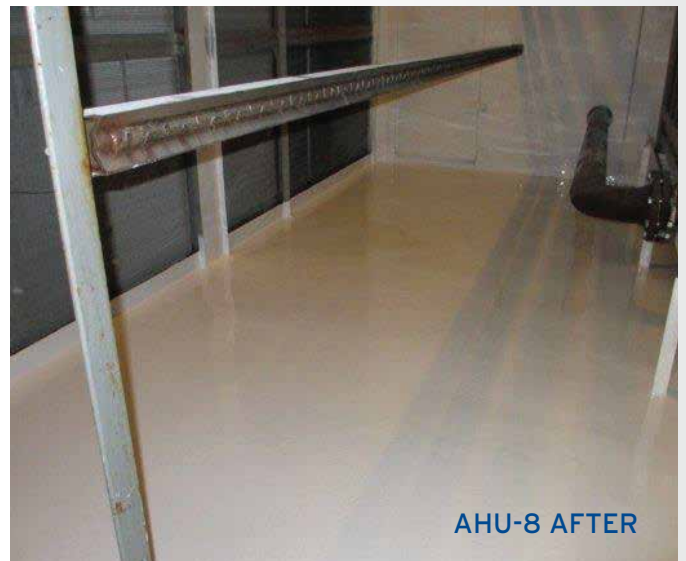
AHU-8 AFTER

AQUIS installed its engineered coating systems on the chamber floors, walls, ceilings, and fan housings.

- Chamber floors were completely sealed to eliminate potential water leaks and restore structure.
- Installation was completed with minimal down time, zero VOCs, and did not require the removal of existing equipment.
- The building’s AHUs are now fully compliant with NFPA 90A and the fire code (ASTM E84 25/50).
- The system now has the benefit of an antimicrobial surface to eliminate bacterial/fungal growth.
