CASE STUDY

EDUCATION SERIES

Boston College addresses corroding air handling units with AQUIS

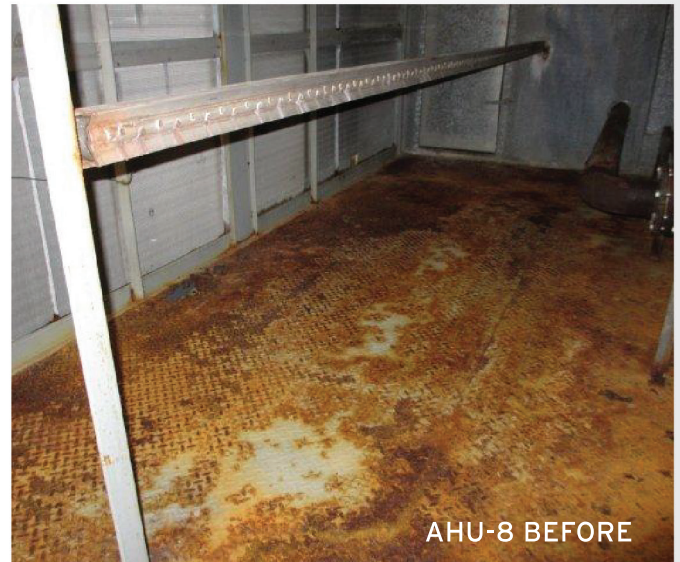
AHU-8 BEFORE

Higgins Hall is a science and research building on the main campus at Boston College, home to over 20,000 students in Chestnut Hill, Massachusetts. Their built-up air handling units, manufactured by Haakon Industries, had significant corrosion on the chamber floors and walls, resulting in holes that could potentially cause damaging water leaks in the building. Boston College selected AQUIS to refurbish the interior of six large units because they wanted to extend the life of the air handlers with a fully compliant and cost effective system.
