## CASE STUDY

# Boston College addresses corroding air handling units with AQUIS

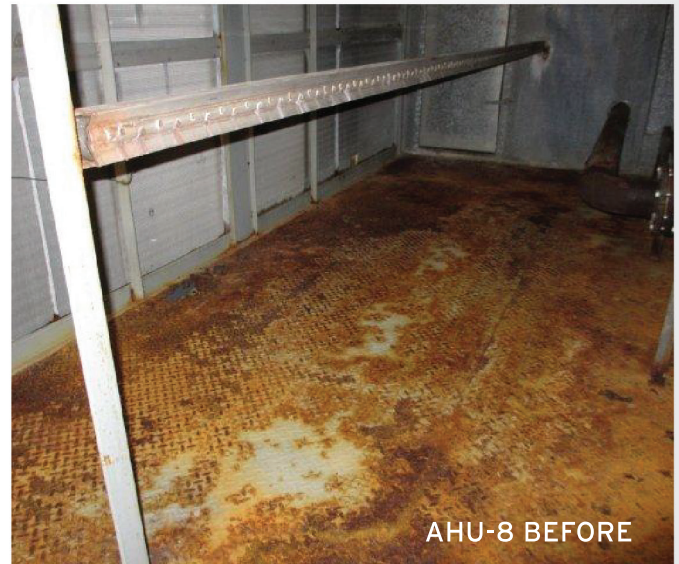
AHU-8 BEFORE

Higgins Hall is a science and research building on the main campus at Boston College, home to over 20,000 students in Chestnut Hill, Massachusetts. Their built-up air handling units, manufactured by Haakon Industries, had significant corrosion on the chamber floors and walls, resulting in holes that could potentially cause damaging water leaks in the building. Boston College selected AQUIS to refurbish the interior of six large units because they wanted to extend the life of the air handlers with a fully compliant and cost effective system.

AQUIS installed its engineered coating systems on the chamber floors, walls, ceilings, and fan housings.

- Chamber floors were completely sealed to eliminate potential water leaks and restore structure.
- Installation was completed with minimal down time, zero VOCs, and did not require the removal of existing equipment.
- The building's AHUs are now fully compliant with NFPA 90A and the fire code (ASTM E84 25/50).
- The system now has the benefit of an antimicrobial surface to eliminate bacterial/fungal growth.
