Extend the Life of Your Air Handlers

Drive Increased Performance with AQUIS Coil Restoration

Increase Coil Efficiency With AQUIS Tube Restoration

The First Real-Time Monitoring System For AHU Coils

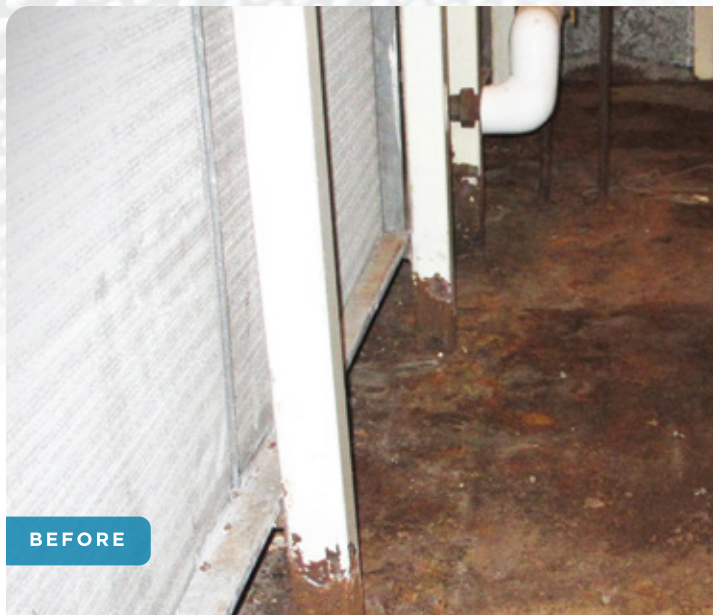
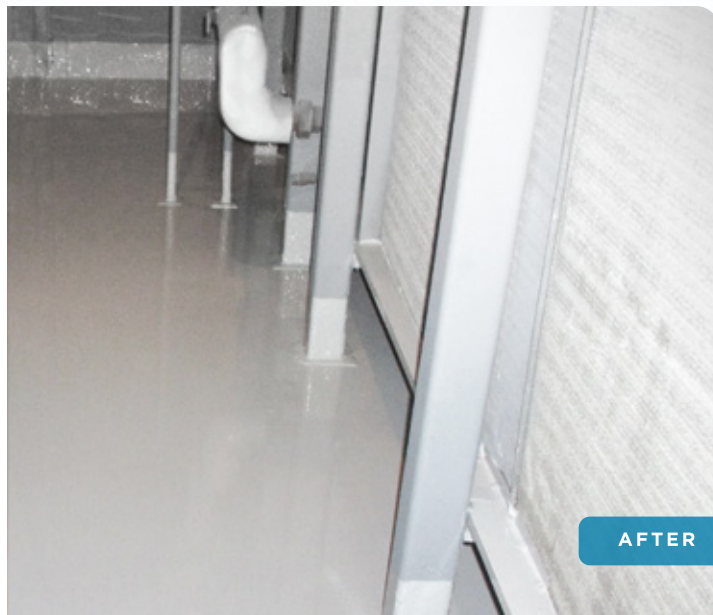
BEFORE

AFTER

AQUIS specializes in the comprehensive refurbishment of mechanical air handling units. With our patented composite coating systems, we extend the life of air handlers without the disruption and high costs associated with replacement. AQUIS offers the **only** fully compliant solution that meets the requirements of NFPA, ASHRAE and the EPA. Having completed thousands of installations nationwide in healthcare, higher education, government, manufacturing and commercial real estate, AQUIS installation teams are the foremost experts at addressing your air handler refurbishment needs.

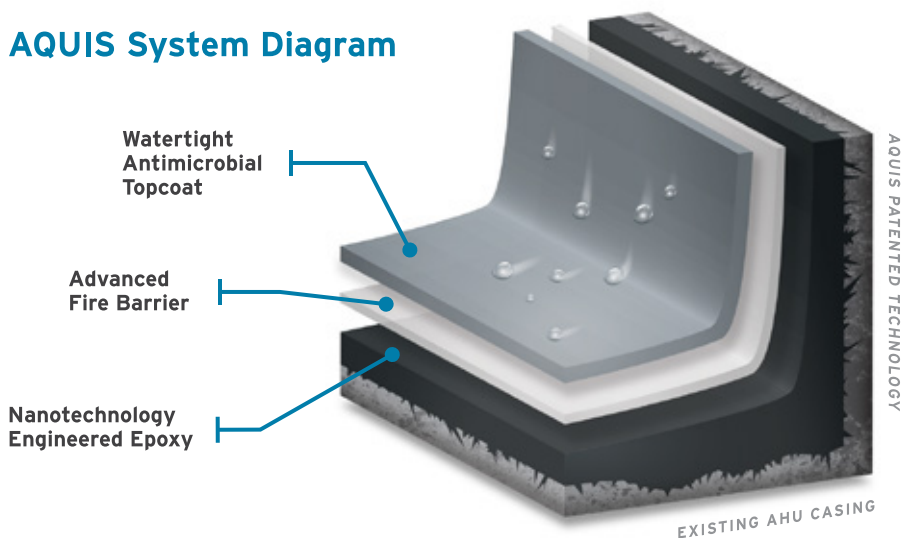
AQUIS System Diagram

- Extends air handler service life
- Stops damaging water leaks
- Restores structural integrity
- NFPA 90A fire code compliant
- Slopes pans per ASHRAE 62.1
- Eliminates standing water
- Improves indoor air quality
- No detectable odors or VOCs
- Minimal equipment downtime

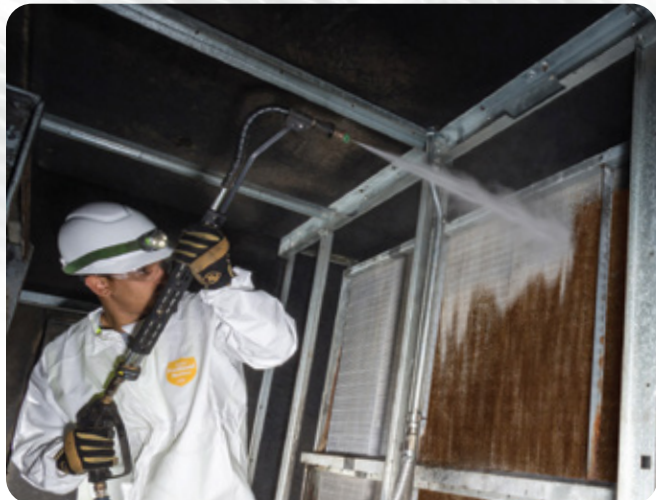
AQUIS, the nationwide leader in AHU renewal, offers a patented process that restores the performance of your aging coils. AQUIS Coil Restoration combines a high-performance sanitization process with a cutting-edge probiotic technology to detach and eliminate biofilms from deep within coils. The result is coils that are cleaned at a microscopic level, driving increased operational efficiency, extending coil service life and improving indoor air quality.

What Are Biofilms? Biofilms are complex communities of microbes, including pathogens and viruses, that form on coil fin surfaces and serve as the foundation for buildup. Over time, biofilm buildup blocks heat transfer and impedes airflow, causing coils to operate well below design specifications.

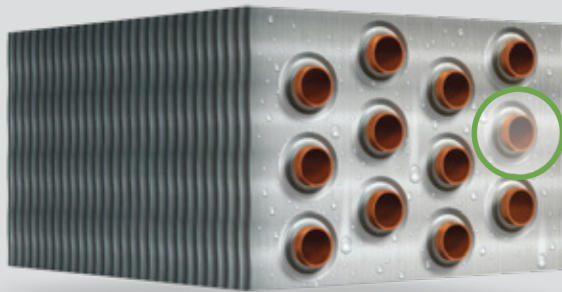
The Problem: Biofilm, scale, and debris inside poorly maintained tubes compromise coil performance by blocking heat transfer and reducing water flow. Microbial induced corrosion (MIC) caused by biofilm within tubes limits the service life of coils.

- Cooling coil is isolated, drained and connected to a probiotic foaming unit.
- Probiotic foam is injected into the coil at low pressure.
- Dense foam is pushed through the coil, removing biofilm, scale and debris, until the foam emerges white.
- Foam is left in the coil for a period of time to further breakdown biofilm.
- Coil is flushed with water and returned to service.

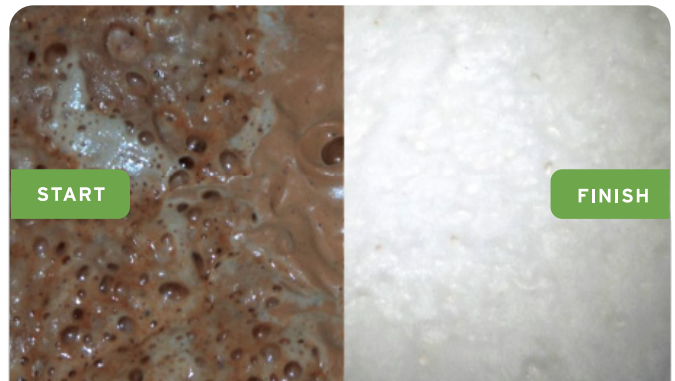
Probiotic foam from coil at the start (left) and finish (right) of the Tube Restoration Process.

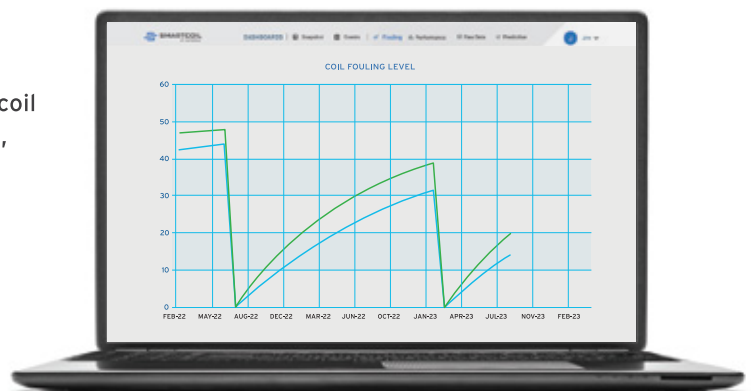
The SmartCoil dashboard provides valuable insight into coil fouling level, coil capacity, energy consumption and more.

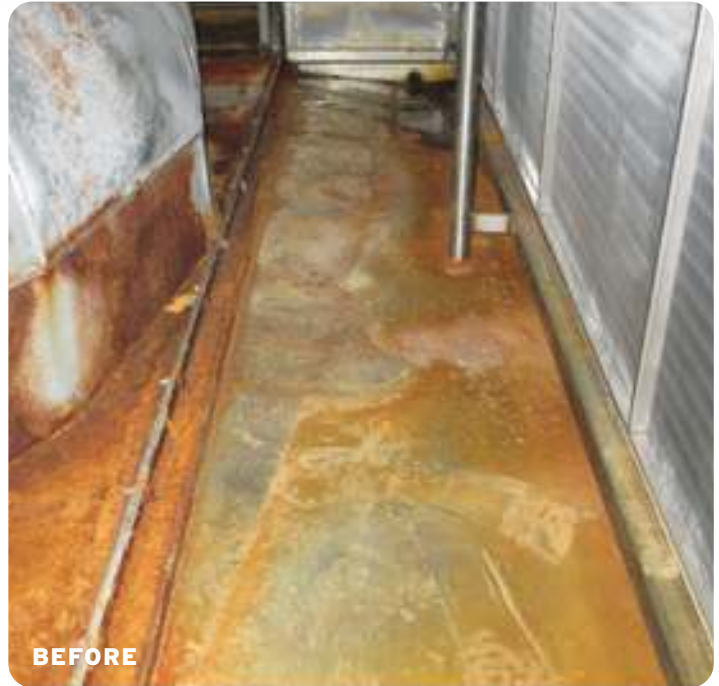
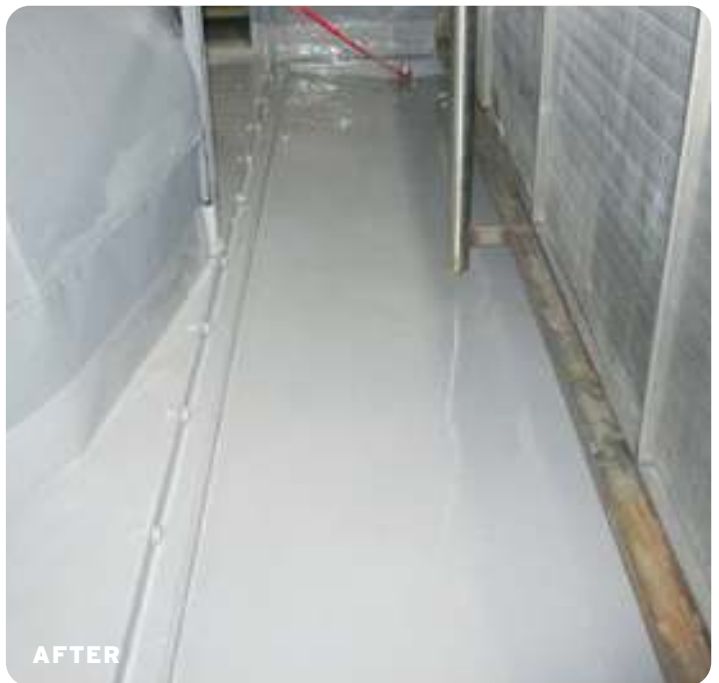
- Chamber floors were sealed with AQUIS' patented CPR-SL composite coating system, which halts corrosion, restores structure and stops leaks.
- Chamber walls, ceilings, and fan housings were sealed with a special antimicrobial coating that repels odorcausing mold and bacteria.
- The AHUs environmental integrity was restored in full compliance with ASHRAE, NFPA and TJC requirements, enhancing indoor air quality.
- Installation was done efficiently, with minimal downtime, and without VOC's nor odors.

An older air handler serving two ICUs had become increasingly problematic. The unit was leaking water, and the chamber floor was rusted and corroded. Replacement wasn't an option due to the unit's location, and a solution was needed to restore its operational and structural integrity. Since the AHU served two ICUs, downtime for repairs was a concern, as was ensuring full compliance with Health & Safety, Infection Control, and TJC.

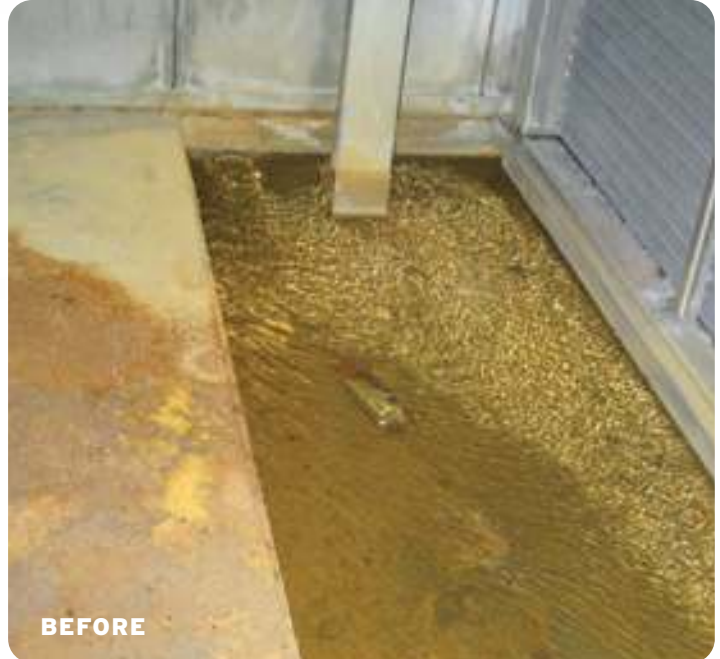
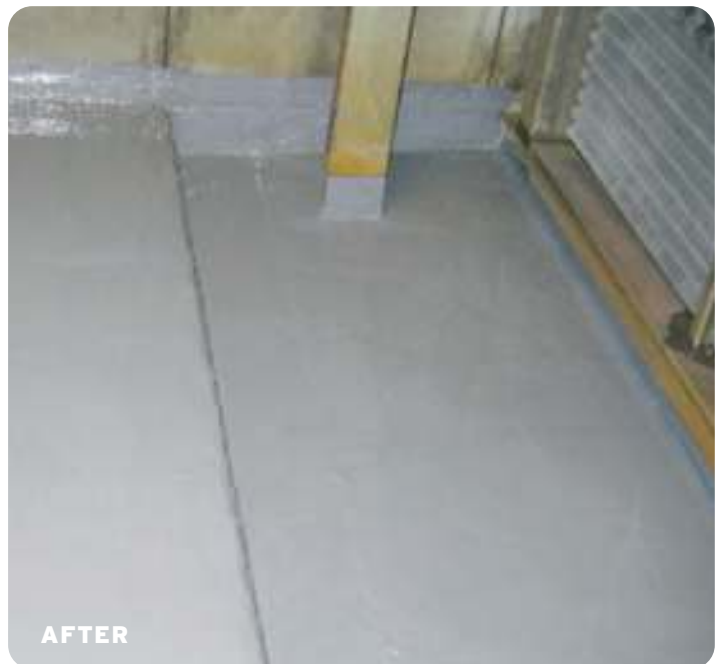
- Chamber floors and pans were completely sealed to eliminate potential water leaks, halt corrosion and restore structure.
- Condensate pans were pitched to eliminate standing water per ASHRAE 62.1.
- Smooth antimicrobial surfaces facilitate easy cleaning and resist the biological growth.
- The AHUs are fully compliant with NFPA 90A and the fire code (ASTM E84 25/50).
- The installation was completed with minimal downtime and no VOC's or detectable odors.

The National Museum of American History, located in Washington DC, was opened in 1964 and serves as home to over 3 million of our national treasures. The museum had 6 mechanical air handling units that were plagued by corrosion and standing water due to a lack of pitch in their condensate pans. They were highly concerned about the threat of water leaks and their potential impact on the museum's many artifacts. The museum was seeking a solution that would address these concerns while also extending the service life of their air handlers.
