Boston College Addresses Corroding Air Handling Units with AQUIS

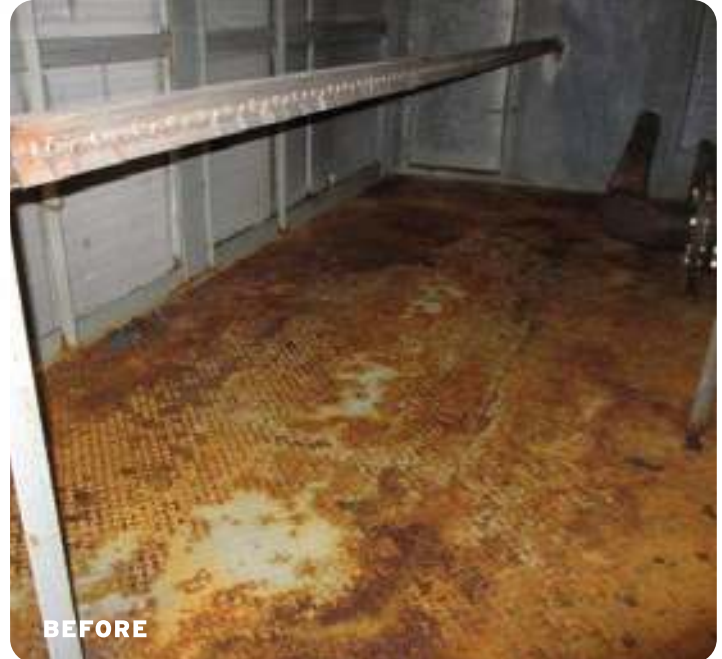
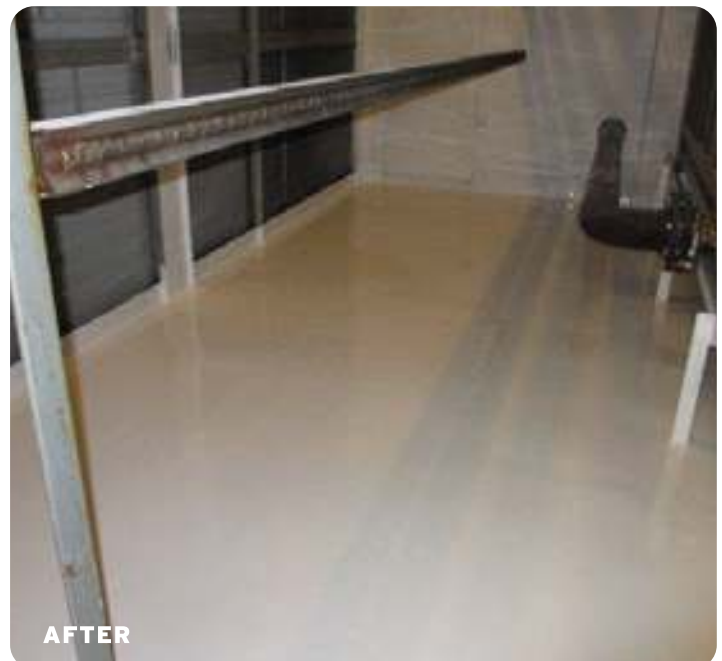
Higgins Hall is a science and research building on the main campus at Boston College, home to over 20,000 students in Chestnut Hill, Massachusetts. Their built-up air handling units, manufactured by Haakon Industries, had significant corrosion on the chamber floors and walls, resulting in holes that could potentially cause damaging water leaks in the building.

AQUIS installed its engineered coating systems on the chamber floors, walls, ceilings, and fan housings.

- Chamber floors were completely sealed to eliminate potential water leaks and restore structure.
- Installation was completed with minimal downtime, zero VOCs, and did not require the removal of existing equipment.
- The building’s AHUs are now fully compliant with NFPA 90A and the fire code (ASTM E84 25/50).
- The system now has the benefit of an antimicrobial surface to eliminate bacterial/fungal growth.
